# Emergency Action Update Ascon Landfill Site

January 3, 2006  
Huntington Beach City Council Study Session

# **Emergency Action Update**

## **Ascon Landfill Site**

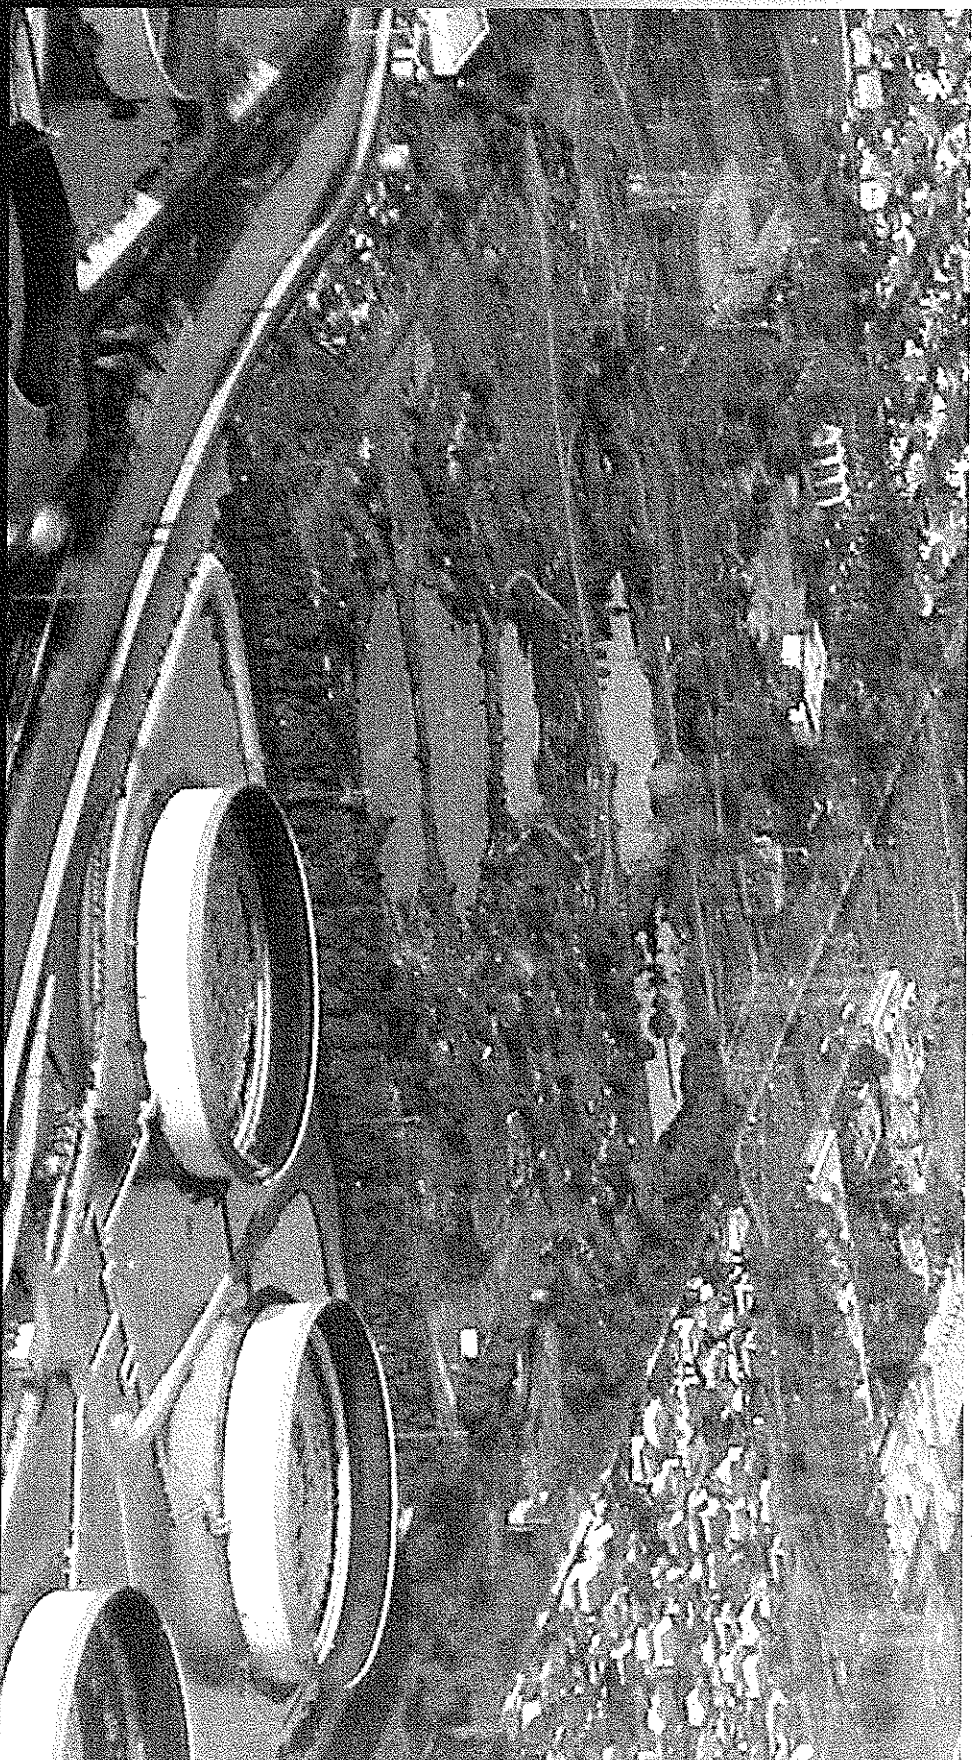
# **Aerial View After Heavy Rains** **January 15, 2005**

- There may be potential failure of the berm along Hamilton Avenue in the event of high water conditions (e.g., next rainy season).
- Berm failure could result in a release of hazardous substances potentially causing an endangerment to public health and the environment.
- DTSC issues an Imminent or Substantial Endangerment determination on May 13, 2005
- DTSC approves an Emergency Action Workplan on July 13, 2005

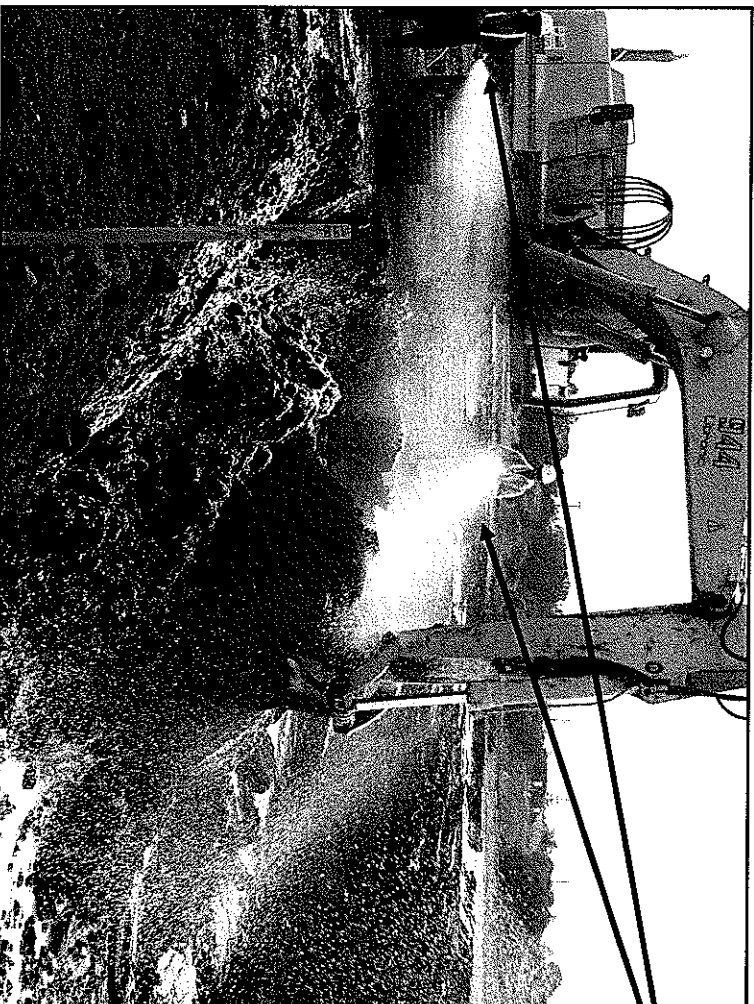
# Excavation in Lagoon 4

Continuous application of foam suppressant while excavating drilling muds

## Excavating northern side of Lagoon 4

In addition to water, foam suppressants, and misters used at the Site for odor and emissions control, Soil Seal was applied to excavated areas at the end of the work day.

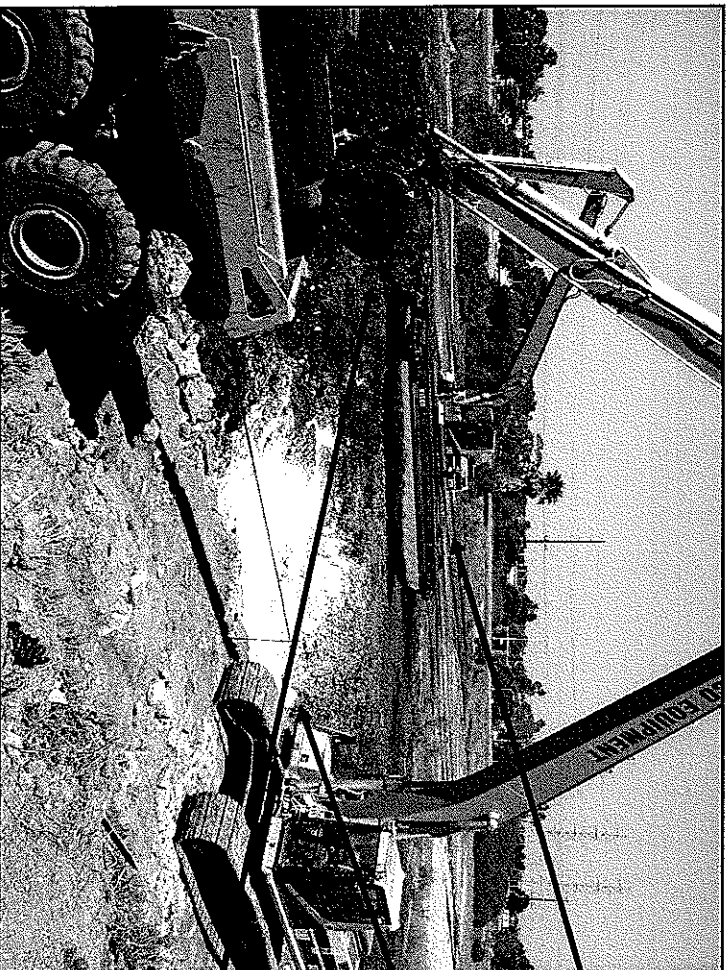
# Excavation in Lagoon 4

Portoon-mounted excavator used to excavate the drilling mud from the lagoon

Application of foam suppressant while excavating drilling muds

Excavator bucket loading excavated material into onsite Moxy truck to bring to stockpile staging area

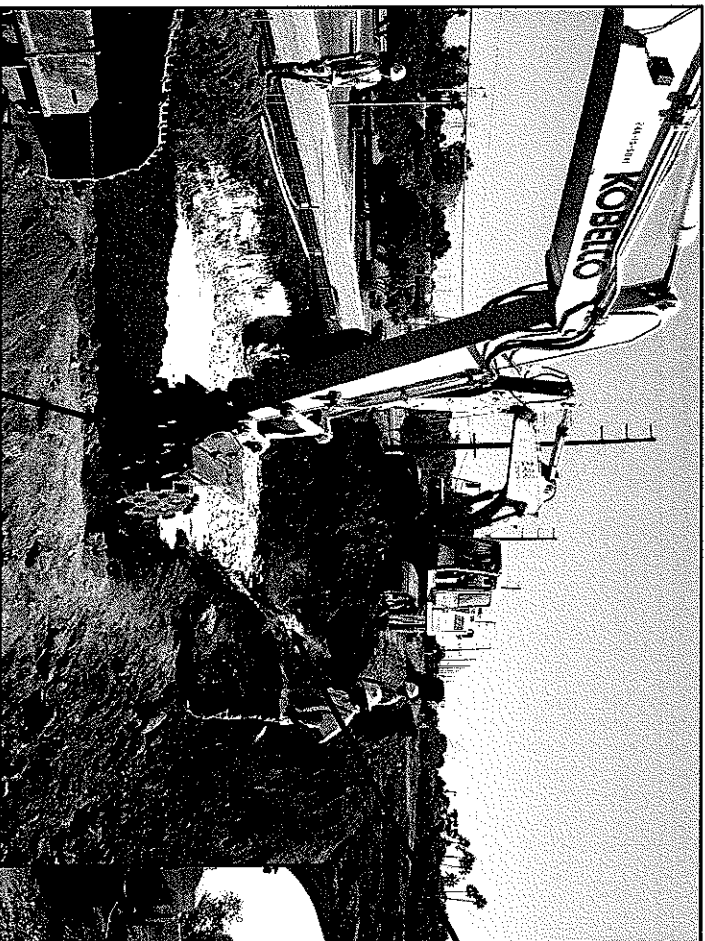
# Berm Excavation and Grading

Compacting the berm material  
after excavation

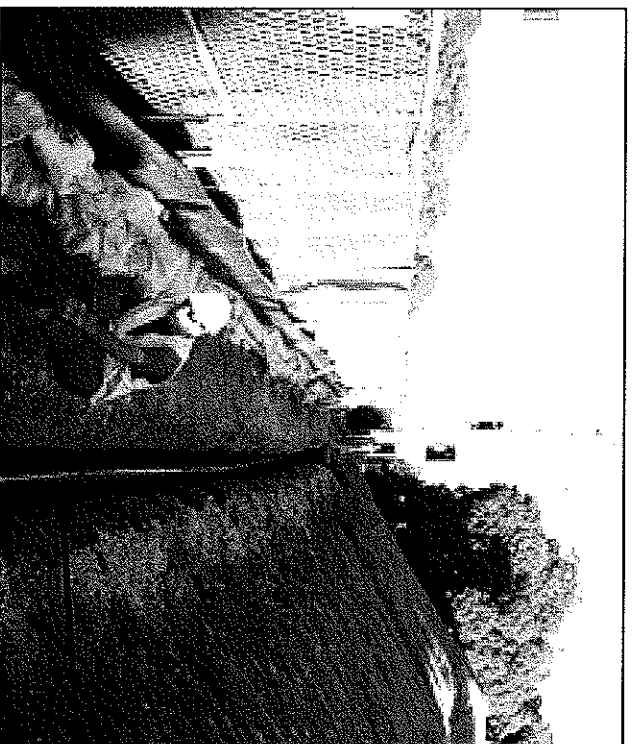
Pipe installation inside the toe drain

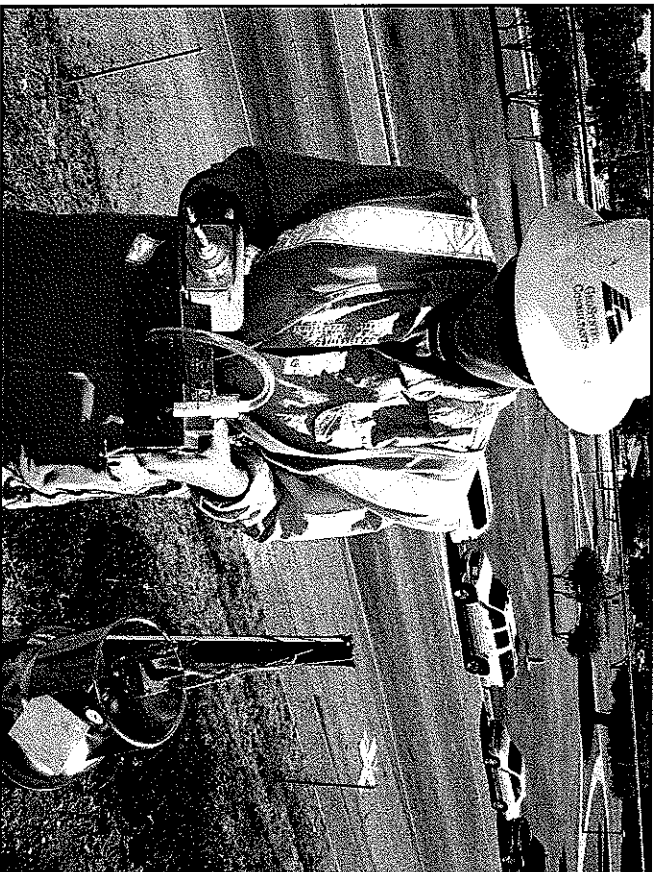
# Real-time Air Monitoring

Air monitoring at perimeter with hand held instrument to give 'real-time' readings

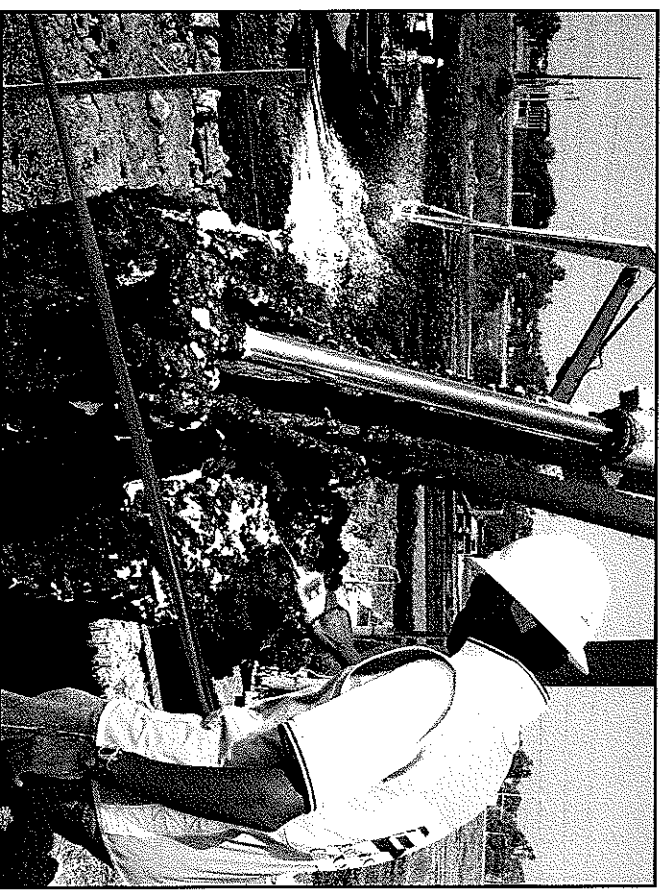
Air monitoring within 3 inches of excavated material with hand held instrument per South Coast Air Quality Management District (SCAQMD) permit

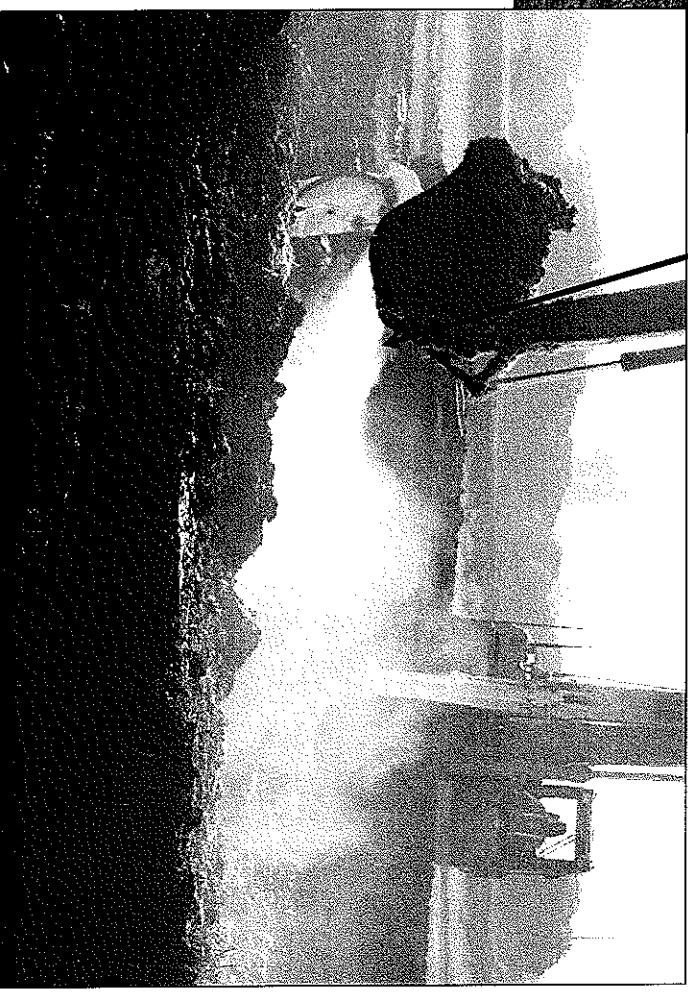
Misters spraying suppressant to help control odors
